Report on the investigations of two fatal accidents
on board the UK registered yacht

CV21

on 4 September 2015

on 1 April 2016

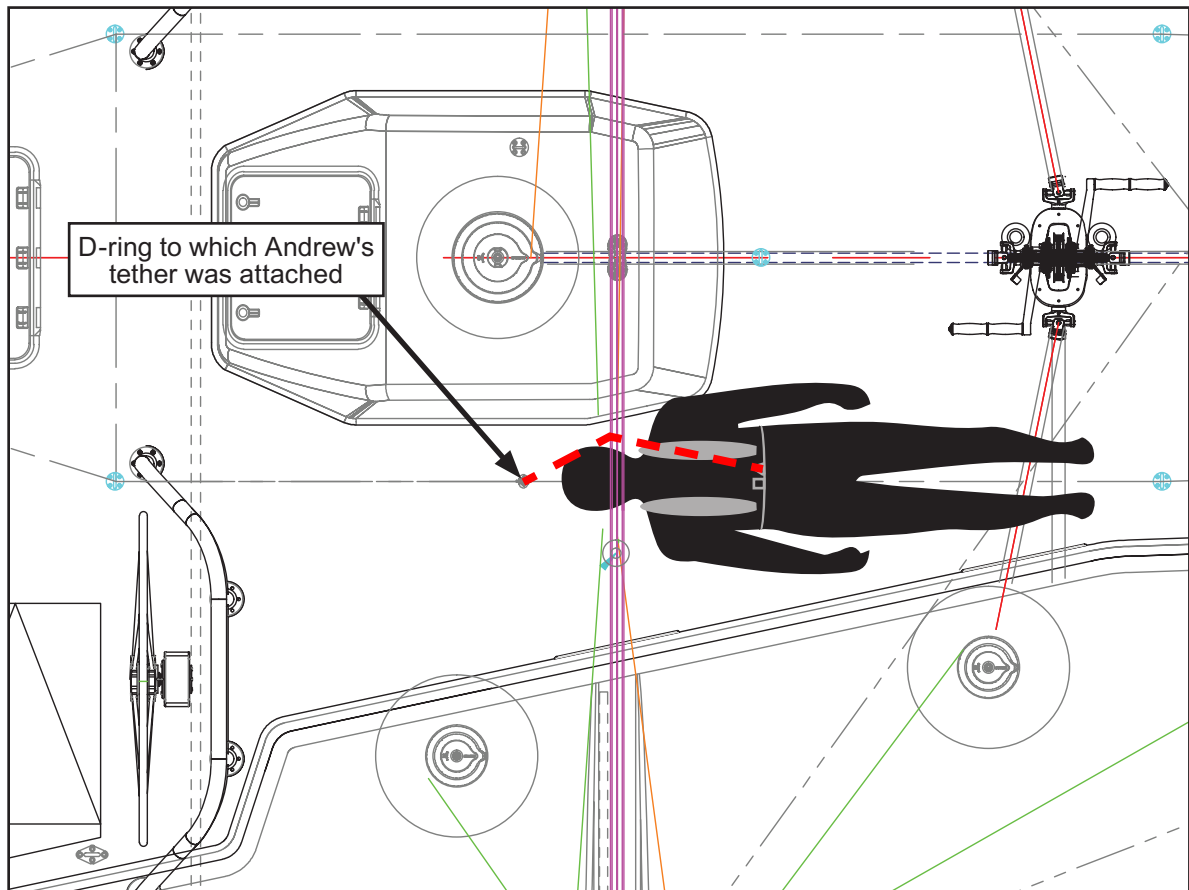
Figure 12: Indicative position of Andrew following gybe

After making sure that it was safe to enter the danger zone the skipper crossed to the starboard side of the deck, where Andrew was lying at a slight angle to the cockpit side coaming. Sarah Young was already with Andrew and informed the skipper that she could not find a pulse. The skipper used his head torch to shine

A postmortem examination of Andrew Ashman identified that he had died as a result of a broken neck from contact with a solid object. There was damage to his spinal cord and he had suffered a brain haemorrhage. The report also stated that Andrew had a bruise measuring approximately 6cm x 3cm on the right side of his neck, along with bruising to the back of his arms, left knee and right shin. Andrew was 170cm tall and weighed 105kg.

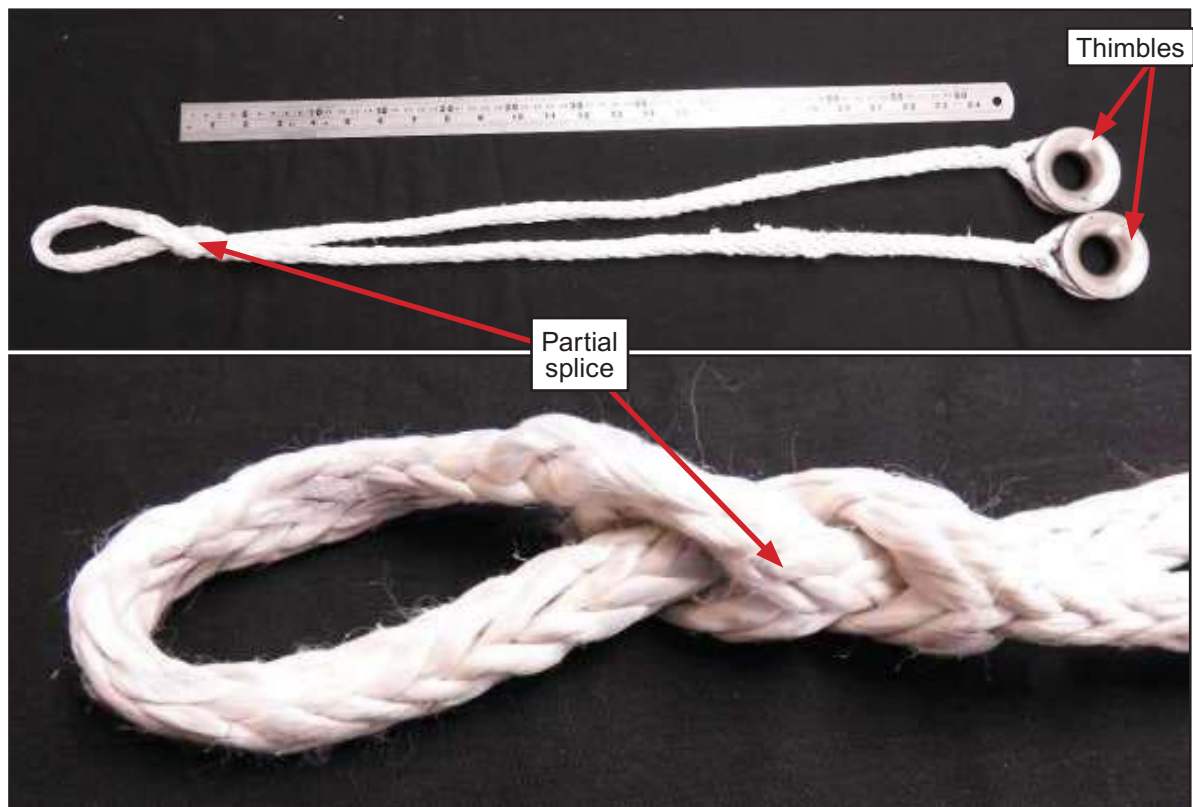
Figure 13: Preventer strop

During previous Races, Clipper yachts had experienced numerous problems with the preventer line arrangement causing severe distortion to cleats and deck fittings. Originally, the preventer line ran from the boom end to a snatch block on the foredeck, then back to the cockpit. This avoided the need for a crew member to go forward to adjust the line. After numerous failures, Clipper sought to replace the snatch blocks with an alternative arrangement.

An assessment of the preventer arrangement by Clipper concluded that it was fit for purpose and the rigger's line managers gave him approval to fit the strop onto the Clipper 70 fleet before the beginning of the 2015-2016 Race. The strengths of the preventer line, strop and pad-eye were estimated but not documented and no estimate of their expected in service loading had been recorded.

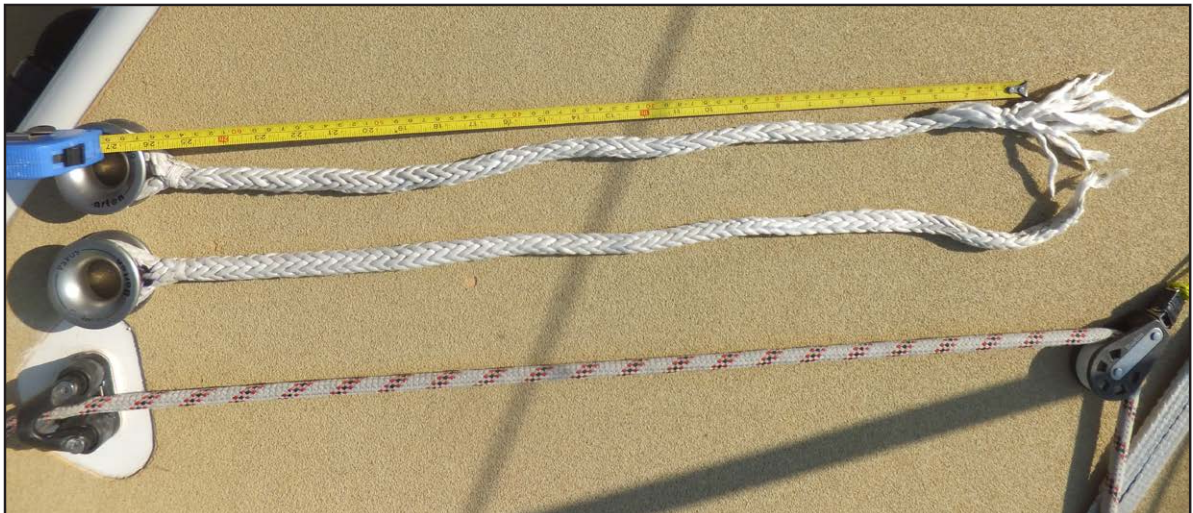
Figure 14: Failed preventer strop

- The boom was complete with no signs of contact with a foreign object
- The lines, sheets and halyards were stowed
- The cockpit area was clear of debris and unmarked
- The preventer strop was found broken (**Figure 14**)
- The traveller was not damaged and was unmarked.

The test report concluded that the primary failure mode was consistent with overload failure at the strop's partial splice, which might have been exacerbated by uneven loading of the splice, resulting in fewer fibres bearing the load, thereby creating a high stress point and pinch points.

Following the accident, actions taken by Clipper were aimed at improving crew safety on board the Clipper 70s, and included: the introduction of a second preventer line; the marking of the area to be avoided while running downwind, when an accidental gybe was possible; and, debriefing the crew with the lessons learned from the preventer strop failure.

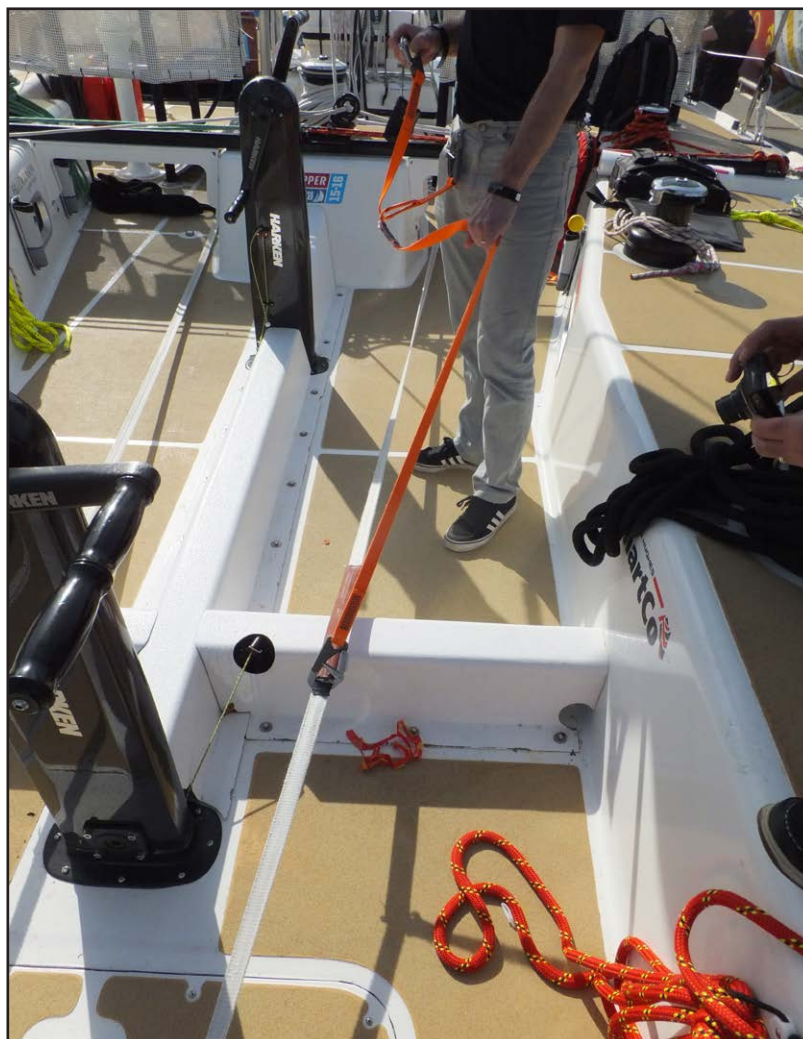
Figure 25: Cockpit jackstay and anti-chafe sleeve

Given the difficulties with moving and working while tethered, the tether securing arrangements, hard points and jackstays must facilitate their ease of use as much as possible. An example in this case was the anti-chafe sleeve on the jackstays fitted to the cockpit floor, which prevented a tether clip from sliding freely over it (**Figure 25**). This inconvenience led to some crew not clipping on at all when moving between the companionway and the helm positions.

The rigging of jackstays and hard points requires compromises, otherwise cockpit and deck layouts could become unworkable, but securing points must be derived with practicality in mind and procedures for their use developed accordingly. The watch leader, unclipping to move quickly aft to deploy the dan buoy in this accident, placed himself at significant risk of being washed overboard. Ensuring a crew member is always tethered within range of the dan buoy must be a factor to be considered when positioning crew at the start of a watch.

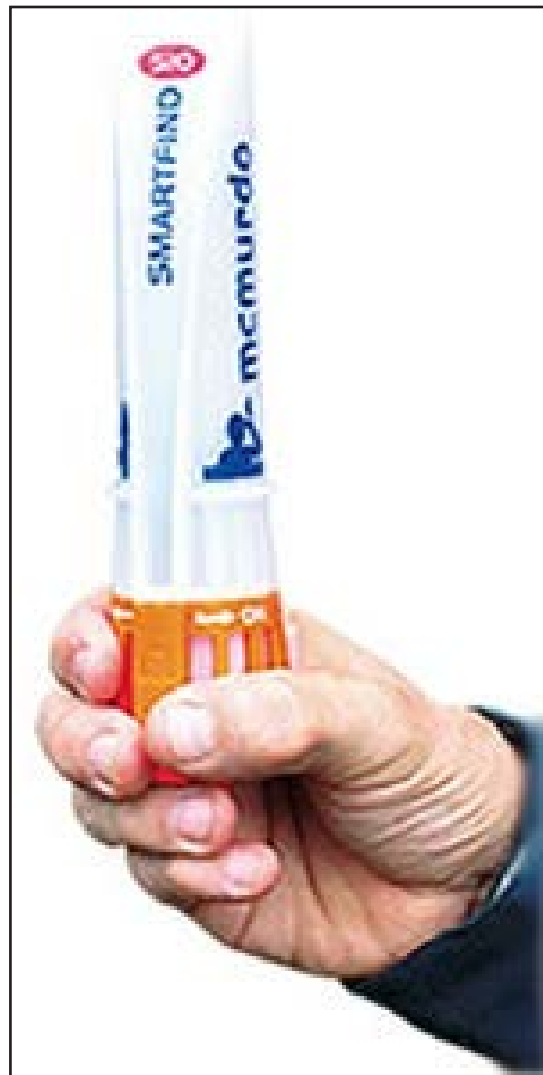
Figure 26: McMurdo S10 AIS beacon held in correct orientation

Attaching an AIS beacon to a dan buoy provides a useful means of locating a man overboard. However, on this occasion its signal was not received by CV21's equipment. The reason for this cannot be determined with certainty as the dan buoy was not recovered. However, it was either not activated correctly, through a lack of familiarity with the equipment, or the signal transmission was hampered by the orientation and positioning of the beacon.

The AIS beacon fitted to the dan buoy was intended to be held vertically out of the water (**Figure 26**) to ensure it was able to locate its position via GPS and transmit the distress message on VHF radio. In the weather conditions encountered, the dan buoy - especially with the additional weight of the AIS beacon attached - is likely to have been blown virtually horizontal. The AIS beacon could at times have been submerged, preventing signal transmission and, with the

beacon not in a vertical orientation its reception range would have been reduced significantly. The effectiveness of fitting an AIS beacon to the dan buoy needs further consideration.
