Report on the investigations of two fatal accidents
on board the UK registered yacht

CV21

on 4 September 2015

on 1 April 2016

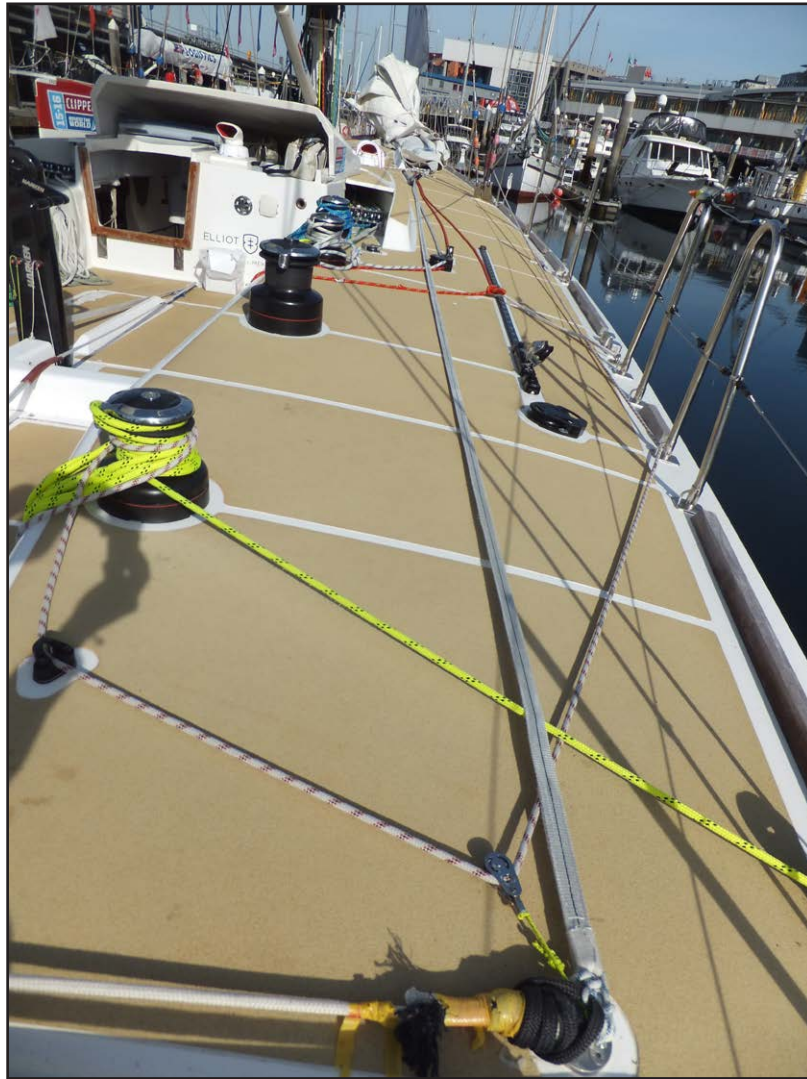
Figure 6: Starboard jackstay

Secure points to which tethers could be attached were distributed throughout the cockpit. To enable ease of movement about the yacht, jackstays were also provided to which tethers could be secured. Jackstays ran forward to the bow from the outboard ends of the mainsheet track (**Figure 6**). On the cockpit floor were two further jackstays (**Figure 7**) that ran from the companionway to the two helming positions. Where the jackstays passed over the grinder axle covers, anti-chafe covers were fitted, which prevented the clips of the tethers from sliding freely.

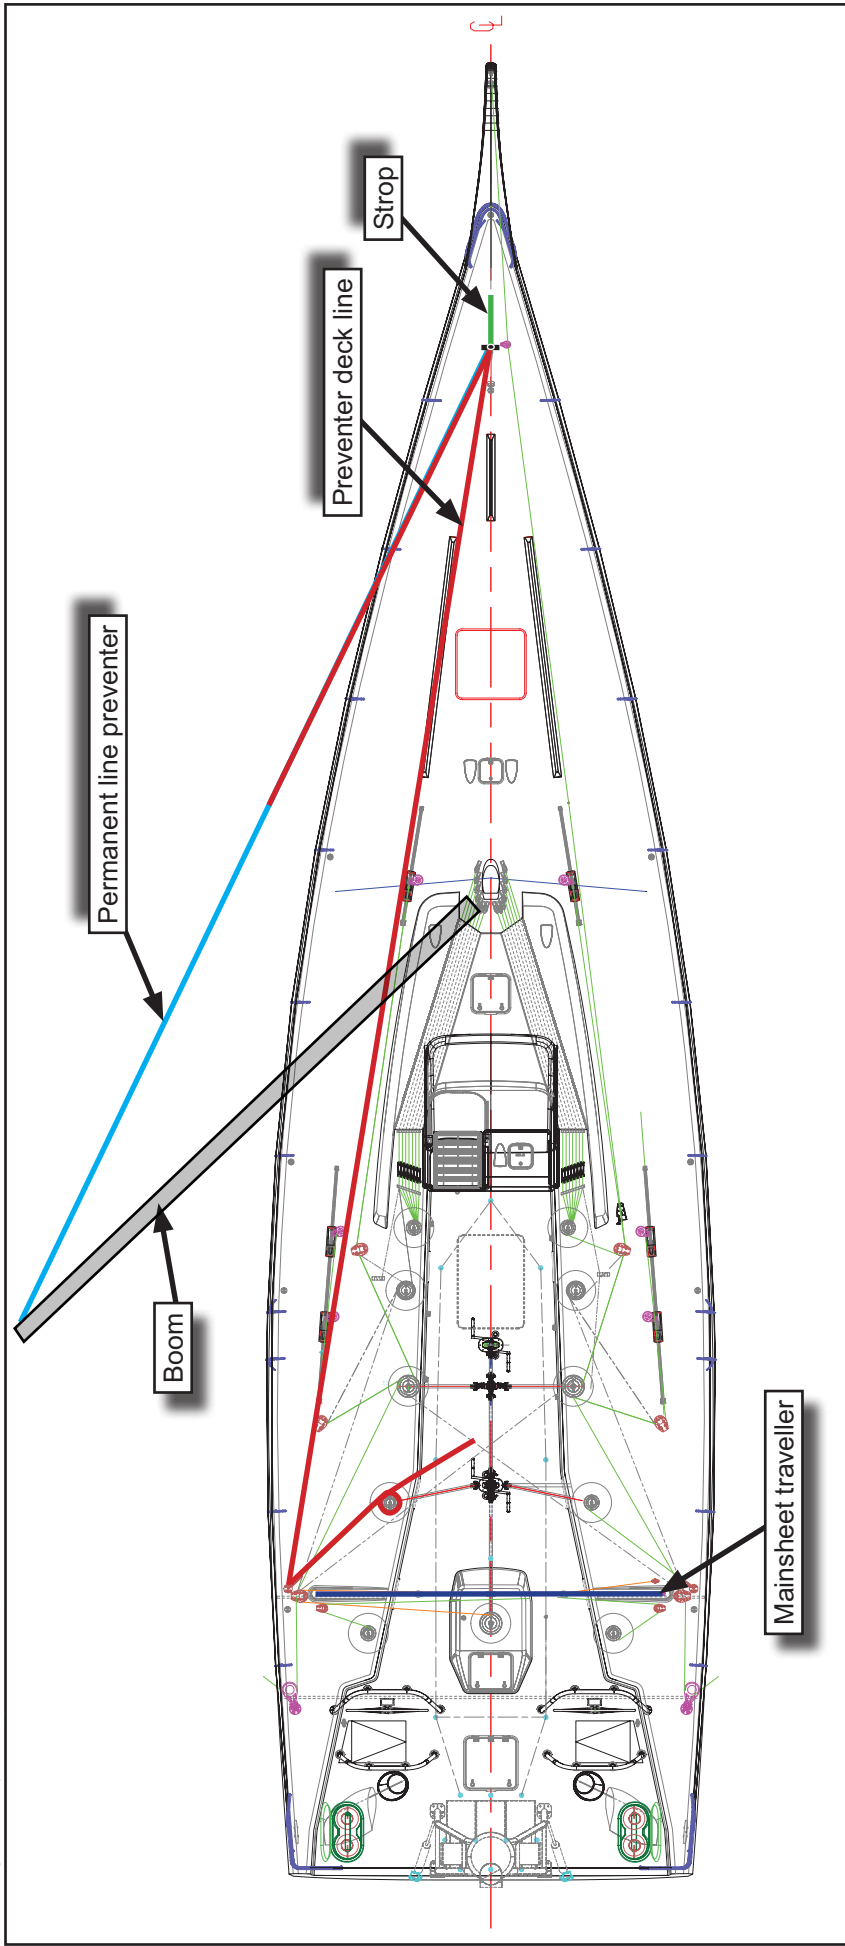
Figure 9: Preventer line arrangement (as illustrated by MAIB)

The cause of the unexpected and sudden movement of the yacht was the accidental gybes, during which the preventer securing strop failed. This strop had been constructed using high modulus polyethylene rope. An assessment of the preventer arrangement by Clipper had concluded that it was fit for purpose. The strengths of the preventer line, strop and pad-eye were estimated but not documented and no estimate of their expected in service loading had been recorded.

Following the accident, actions taken by Clipper were aimed at improving crew safety on board the Clipper 70s, and included: the introduction of a second preventer line; the marking of the area to be avoided while running downwind, when an accidental gybe was possible; and, debriefing the crew with the lessons learned from the preventer strop failure.

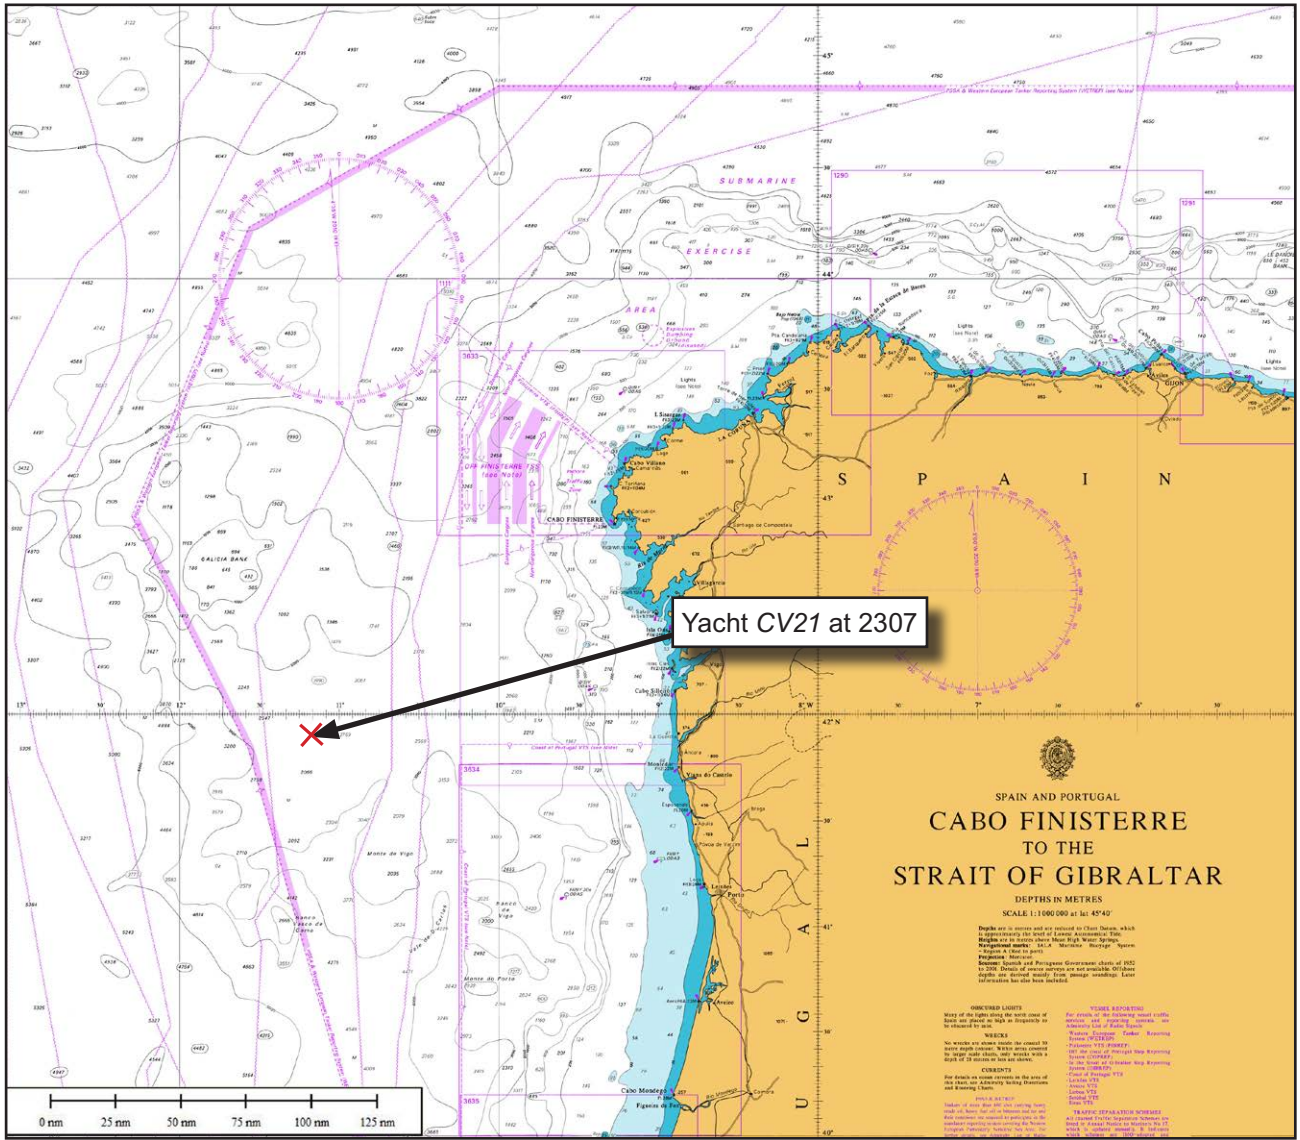
Figure 10: Position at 2307 and logbook entry

Andrew and another crew member sat on the upper, starboard side of the deck waiting to take their turn on the wheel. The helmsman was changed every 30 minutes, and at 2230 Andrew took the helm. He helmed for 30 minutes, and at 2300 he passed the helm to the other crew member who, although a competent helm, was nonetheless inexperienced. At 2307⁴, Sarah Young logged the vessel's position in the logbook (**Figure 10**).

⁴ The log entry was marked as 2200 (UTC) but was in fact CV21's position at 2307 (UTC+1).

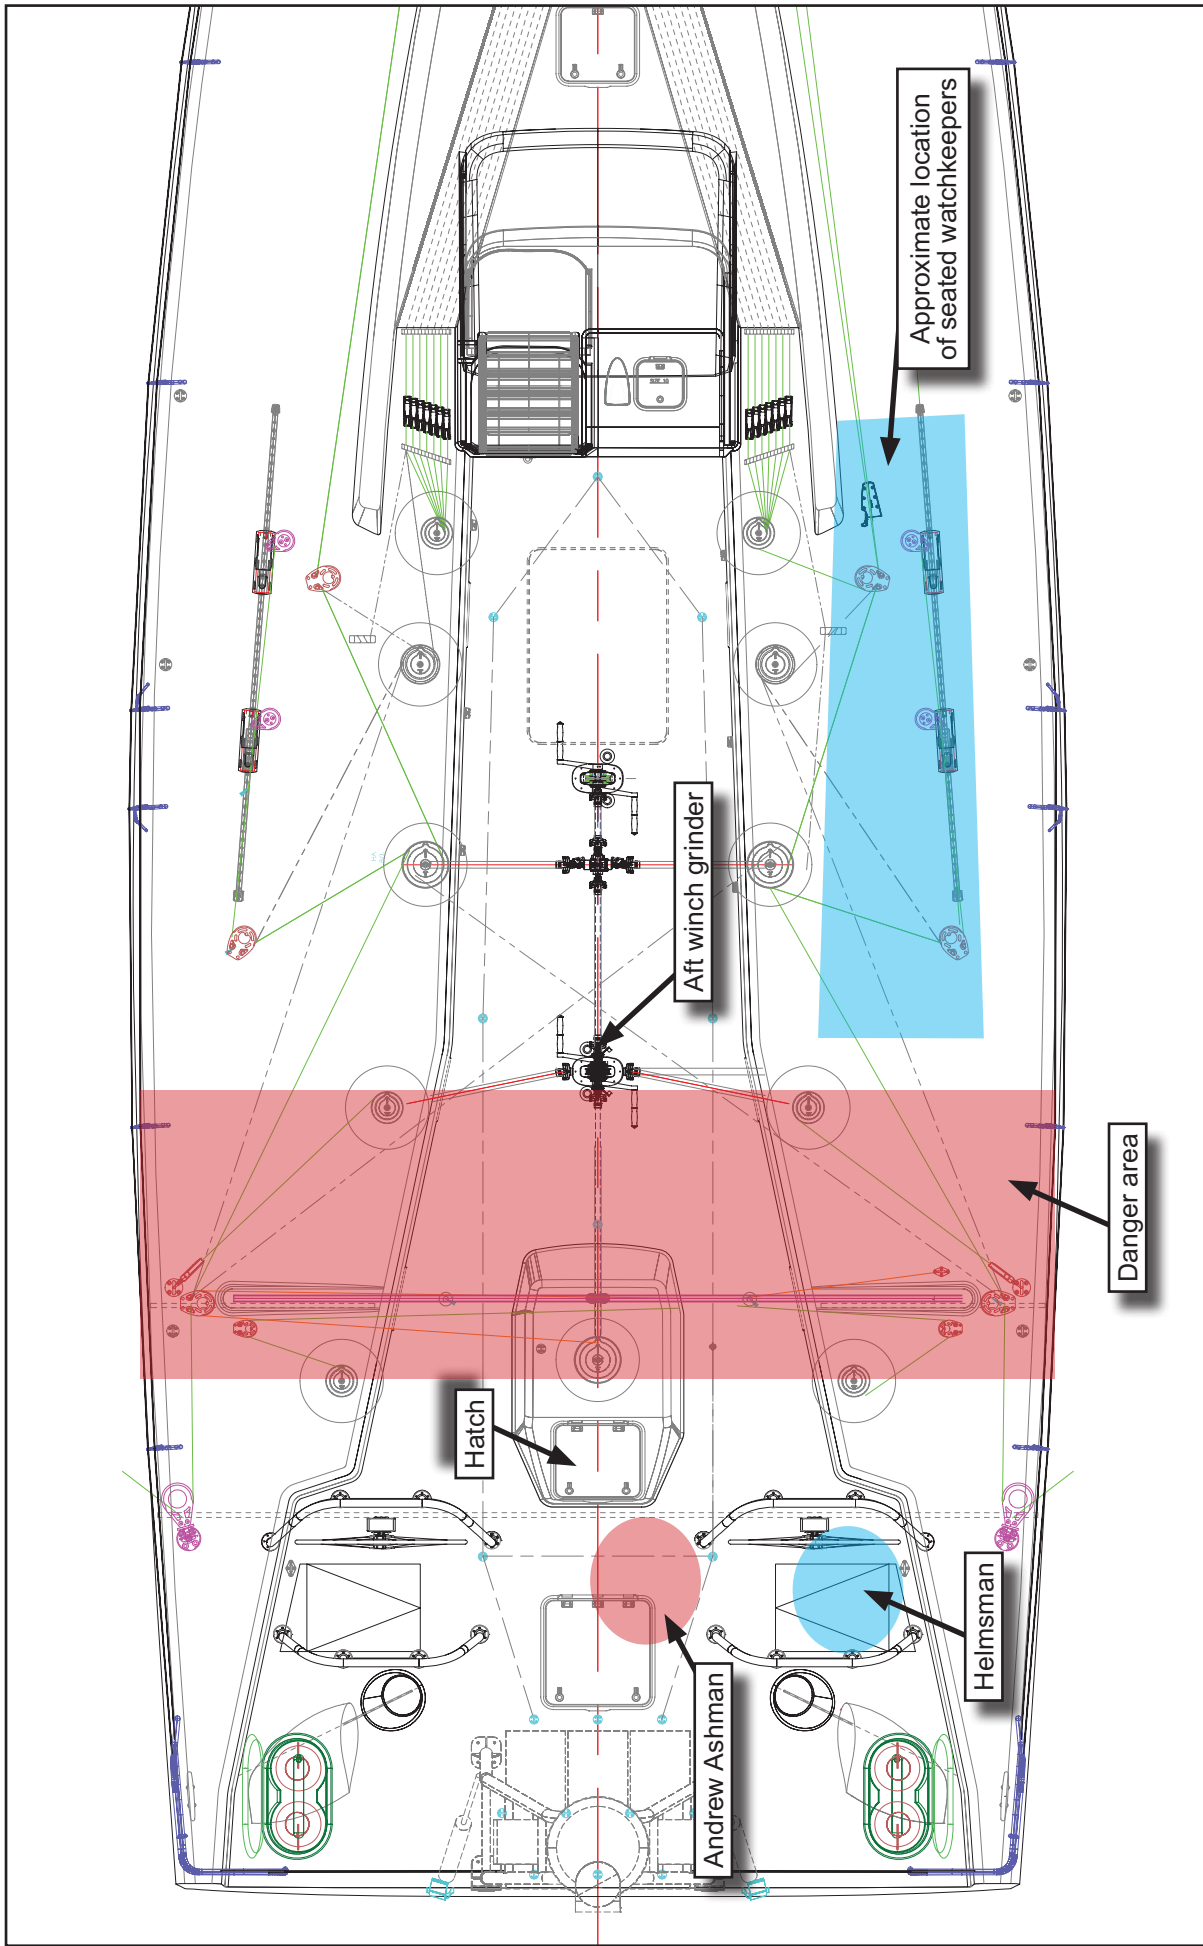
Figure 11: Position of crew prior to accident

At 2330, the helm was passed to one of the least experienced helmsmen, with Andrew monitoring him. Andrew was standing aft of the traveller and to port of the helmsman (**Figure 11**), with his tether fixed to a D-ring to starboard of the navigation station hatch.

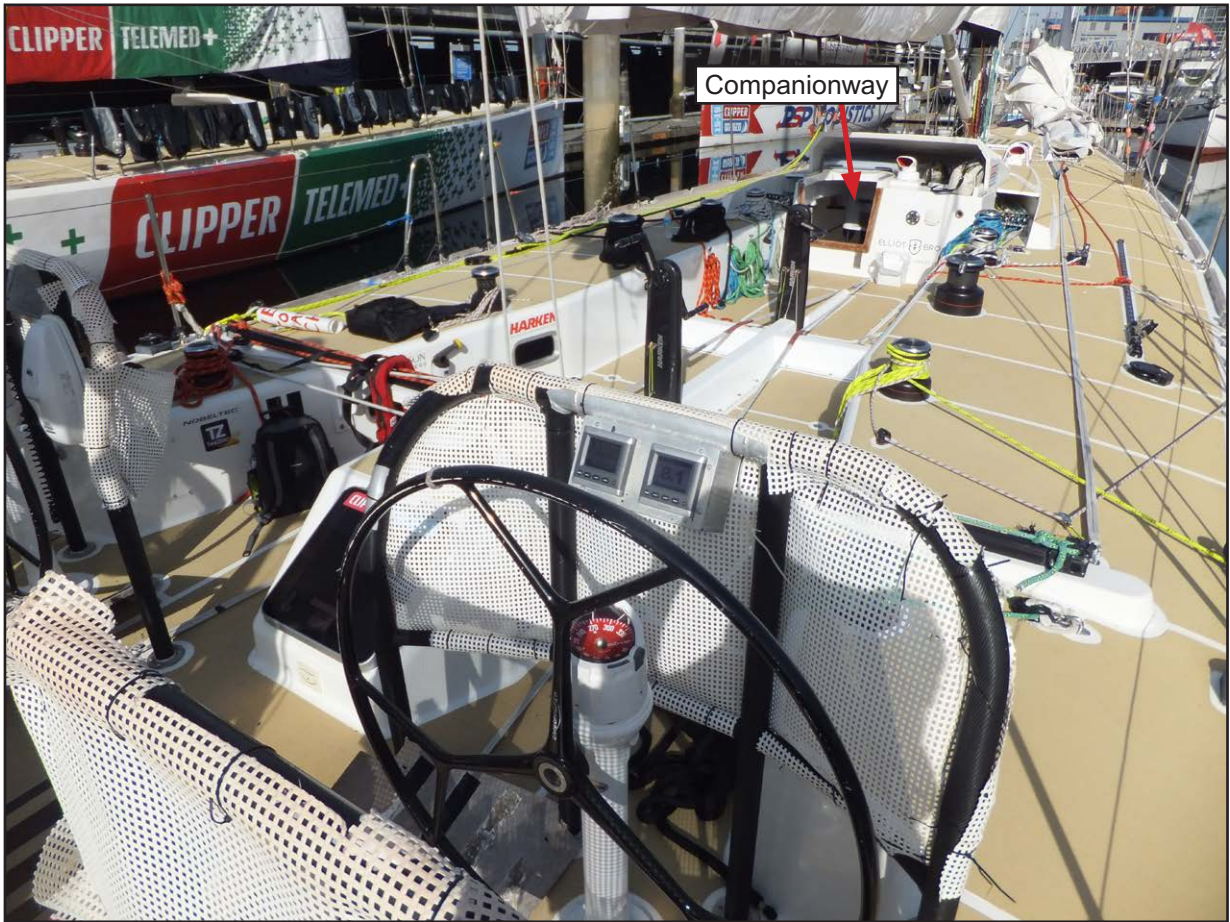
Figure 17: Cockpit showing companionway

Leaving the three crew below to get ready, Sarah climbed back up the companionway steps into the cockpit (**Figure 17**). Without first clipping on her tether, she assisted another crew member in reattaching a winch handle pocket (**Figure 18**) onto the port forward side of the cockpit. The combination of a wave breaking over the deck from the port side and CV21 heeling further to starboard led to Sarah losing her footing, and falling over and down the deck, ending up lying next to the starboard guardrail with a winch handle in her hand. The watch leader, who was sitting on the starboard side of the cockpit, tried to grab her, but before he was able to do so another wave washed down the starboard side, forcing Sarah over the side.

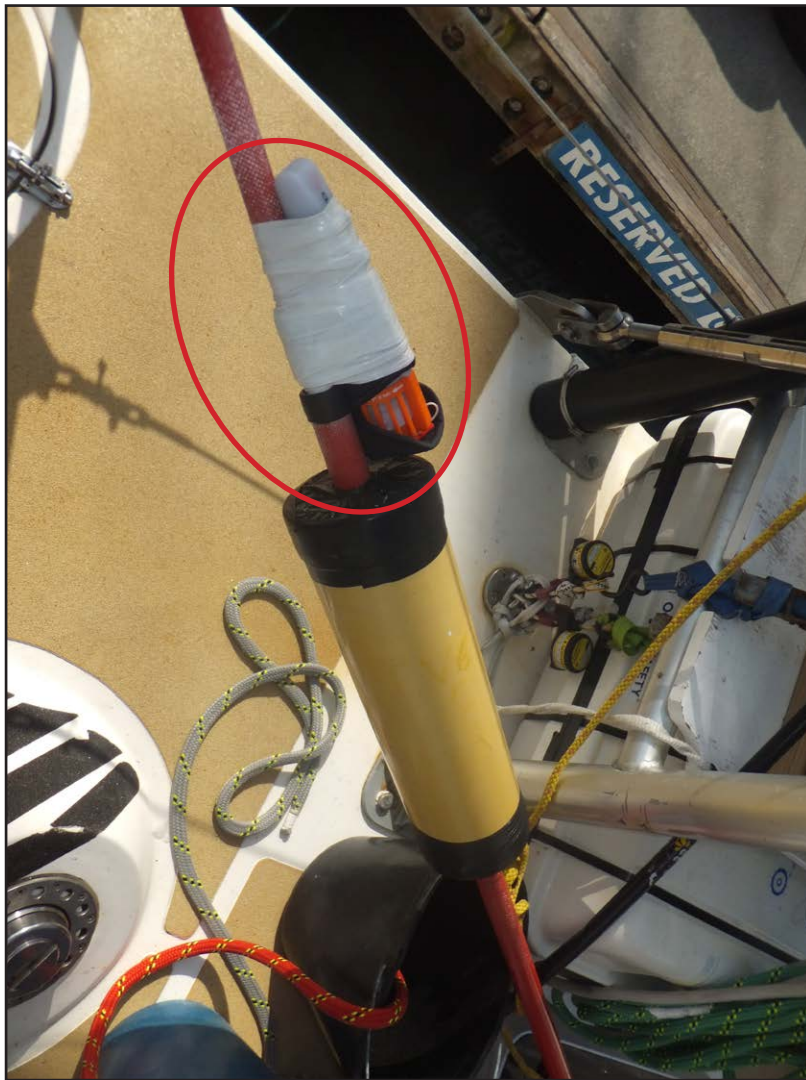
Figure 23: McMurdo S10 AIS beacon mounted on dan buoy

The dan buoy had taped to it an AIS beacon, which was a different model to that fitted to the lifejackets. This AIS beacon was submersible to 60m water depth and had a typical reception range of 4nm at sea level (**Figure 23**).

beacon not in a vertical orientation its reception range would have been reduced significantly. The effectiveness of fitting an AIS beacon to the dan buoy needs further consideration.

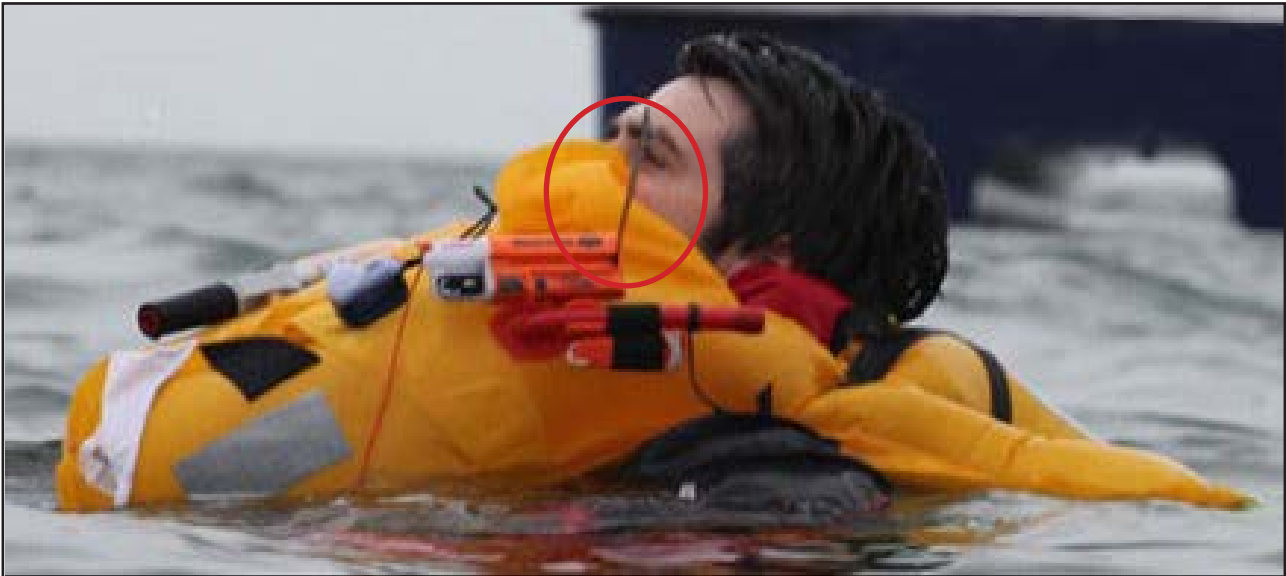
Figure 27: AIS beacon with antenna deployed on inflated lifejacket

As demonstrated in this accident, the fitting of personal AIS beacons to individual crew members would appear to offer a more reliable option. Firstly, it locates the person, not a dan buoy thrown over at some stage after the MOB. Secondly, because the orientation of the AIS beacon antenna when deployed will maximise the AIS transmission (**Figure 27**). Thirdly, it is small enough to be carried on a person and be immediately available at all times.

Ideally, AIS beacons should auto-activate. However, the AIS beacons that were voluntarily fitted to the lifejackets of the majority of participants in the Race were manually activated, therefore requiring the casualty to be conscious when in the water. However, the current lack of availability of an auto-activating AIS beacon should not prevent Clipper requiring the compulsory carriage of personal AIS beacons for all Clipper crew in future races.
